DEPARTMENT OF TRANSPORTATION**DIVISION OF ENGINEERING SERVICES**

Quality Assurance and Source Inspection

Contract #: 04-0120F4Cty: SF/ALA Rte: 80 PM: 13.2/13.9File #: 1.28**WELDING INSPECTION REPORT****Resident Engineer:** Siegenthaler, Peter**Address:** 333 Burma Road**City:** Oakland, CA 94607**Report No:** WIR-017619**Date Inspected:** 25-Oct-2010**Project Name:** SAS Superstructure**OSM Arrival Time:** 1000**Prime Contractor:** American Bridge/Fluor Enterprises, a JV**OSM Departure Time:** 1830**Contractor:** American Bridge/Fluor Enterprises, a JV**Location:** Job Site

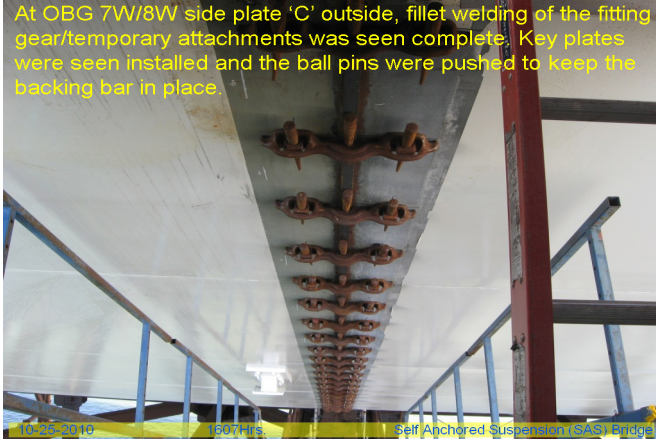
At OBG 7W/8W side plate 'C' outside, fillet welding of the fitting gear/temporary attachments was seen complete. Key plates were seen installed and the ball pins were pushed to keep the backing bar in place.

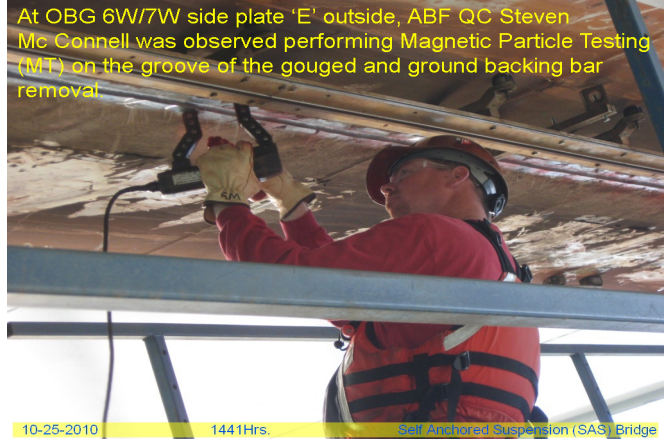
At OBG 6W/7W side plate 'E' outside, ABF QC Steven Mc Connell was observed performing Magnetic Particle Testing (MT) on the groove of the gouged and ground backing bar removal.
